Polyepoxy Compositions as an Effective Material for Extra-Clinical Self-Installation of Large Fillings and Dental Bridges in Case of Complete Destruction of Lateral Teeth

Citation: D Starokadomsky, M Reshetnyk, N Moshkivska, O Tymoshchuk and O Kachorovska. Polyepoxy Compositions as an Effective Material for Extra-Clinical Self-Installation of Large Fillings and Dental Bridges in Case of Complete Destruction of Lateral Teeth. Biomed J Sci & Tech Res 65(3)-2026. BJSTR. MS.ID.010191.

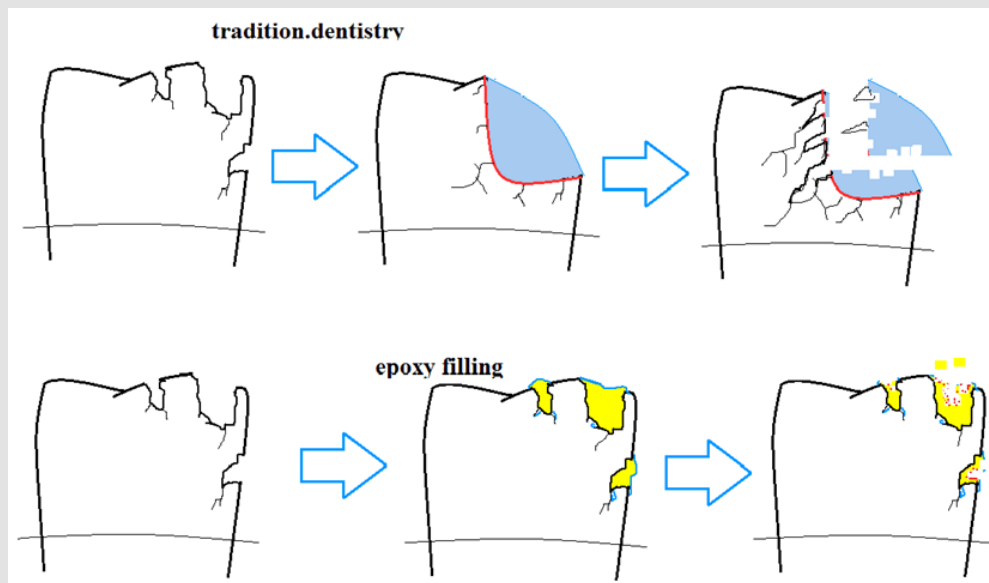
Figure 2: Restoration and its subsequent aging/destruction with traditional and epoxy execution

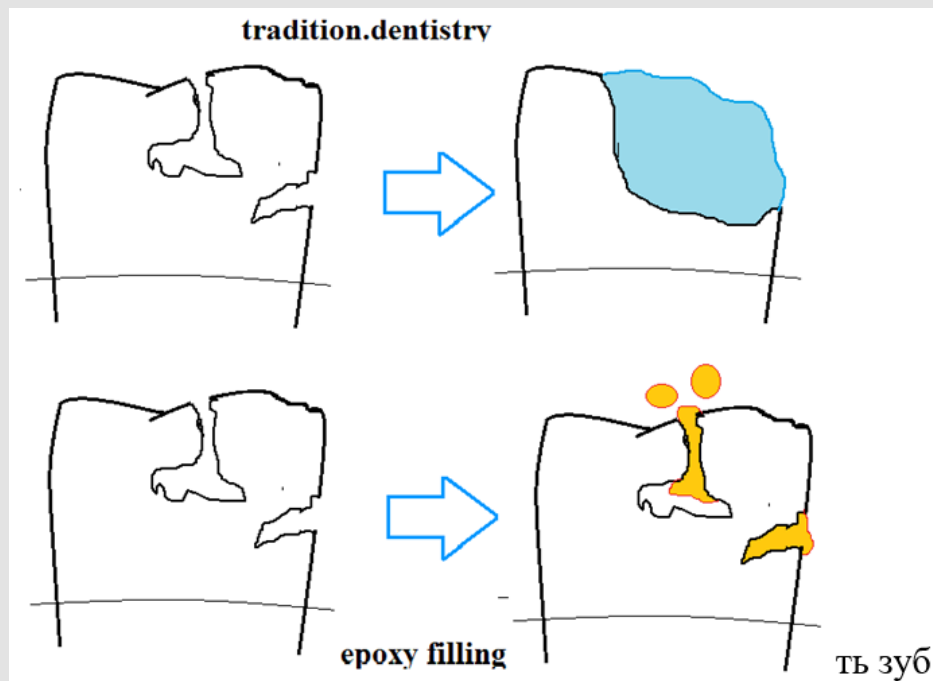
Figure 3: Comparison of traditional and epoxy fillings.

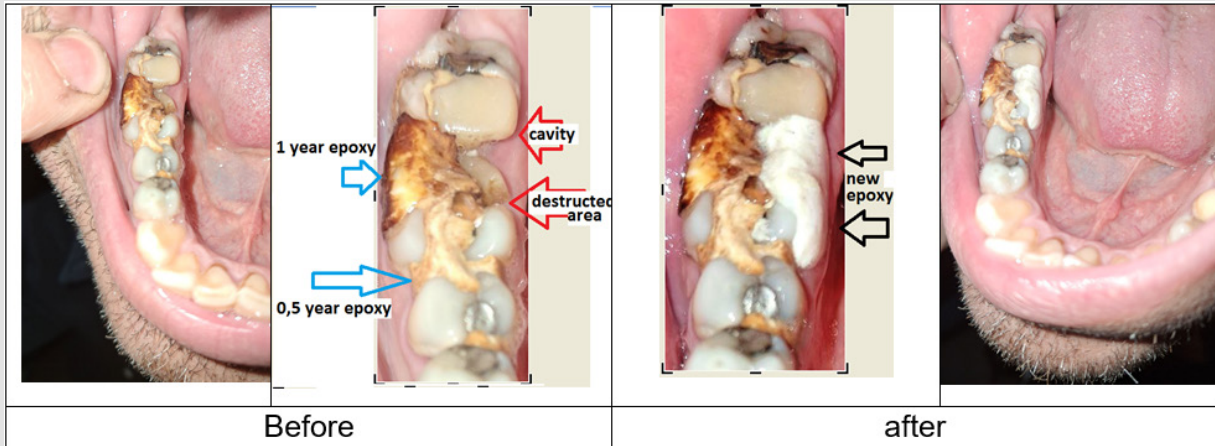
Figure 4: An example of successful restoration of destroyed areas of the lateral teeth of a 50-year-old patient.

Figure 4 shows a typical case of such a restoration. Due to decay of the 6th tooth in the area of contact with an old (20-year-old) filling, half of its upper part has chipped off. Long-standing caries also affected the adjacent tooth. Several self-restorations were performed,

which worked successfully for several years (1 and 2). In 2026, they fell out simultaneously (during a food spill), preceded by intermittent pain and micro-movement of the fillings (fixed by the patient's tongue). Along with them, the deep old filling, which had caused the decay, fell out. Following the technique, the patient prepared and installed a new one-piece epoxy denture himself on the same day. A typical case is shown in Figures 4 & 5 which describe the complete loss of the patient's tooth No. 6 and partial loss of the tooth No. 7. Prior to the loss, the patient complained of periodic dull pain (including at night), characteristic of the mobility of old fillings that had lost contact and were delocalizing. The socket of tooth No. 6 was left with nothing but an exposed root remnant with sensitive living tissue. The patient was encouraged to try the epoxy-technique himself, eliminating the painful and time-consuming (and costly) traditional preparation steps-applying a medicated compress; nerve removal; root canal cleaning; etching; strength testing of Dentin bottom, etc. The installation process was simplified and was performed without lighting (an iPhone flashlight), heat, or water (antiseptic and cotton wool were used). After 20 days, another small epoxy filling was added to the existing epoxy onlay in the adjacent tooth No7 (also partially decayed) with signs of deep caries (Figure 6). It was placed in domestic and almost unsanitary conditions (in a utility room) using a sterilized screwdriver (instead of a spatula), a DVD instead of a glass slide, and clean wipes. This filling also performed well and remained working undestroyed until the test removal of both fillings (Figure 6).

Figure 4 clearly shows the condition of the self-installed denture (see Figure 1) after one month of active use. For clear markings, the test subject rinsed only with red alcohol-based solutions (wine). The denture was removed in the usual manner (with gentle rocking movements) and cleared of food. Food debris was noted on the sides and in one spot on the bottom of the denture. However, the different coloring indicates that the contact area (bottom surface) withstood the test period and loads well. The composite showed no signs of decomposition or even swelling. It was self-installed using the well-known Korega gel, and a day later (when the gel had dissolved), it was cleaned and reinstalled on the epoxy base. Over the following period, the patient stopped complaining of both discomfort when chewing and the associated pain from the aching tooth (which had plagued him for several decades). It should be noted that any destruction of such a prosthesis, or even simple discomfort, can easily be replaced with a new epoxy one. Similar results were obtained when restoring another set of teeth, the upper lateral series. This case is similar to the one described above, in a rather advanced destructive stage with signs of very deep caries (Figure 8). The installed polyethylene epoxy bridge-like prosthesis was attached only to the remaining teeth, the gums, and the implant of the fifth tooth. It fell out and was reinserted several times until it became firmly established within six months. Then it fell out again and was immediately reinserted again (in the fall of 2025), af-

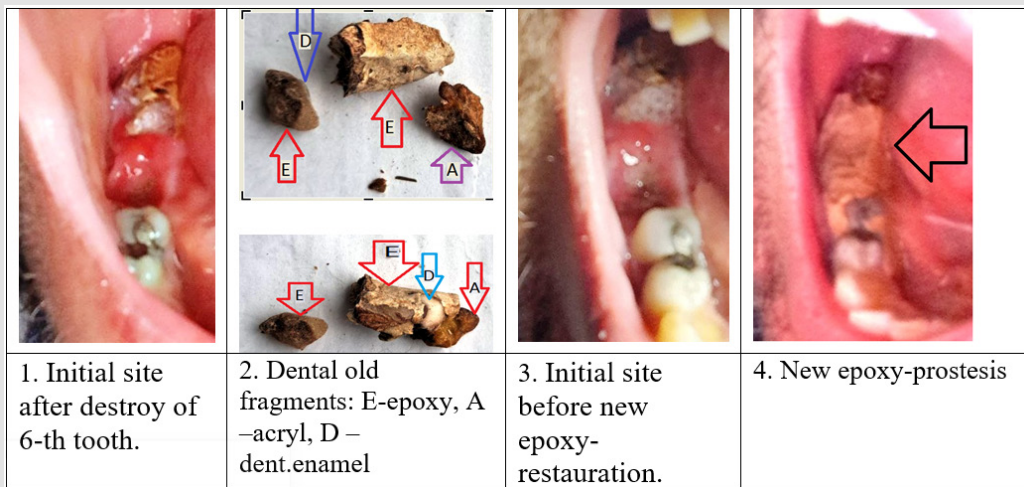
Figure 5: Fresh (1 hour ago) collapse of a complex of old (acrylic) and new (epoxy) fillings with the remains of a tooth, and the view after self-installation of an epoxy prosthesis.

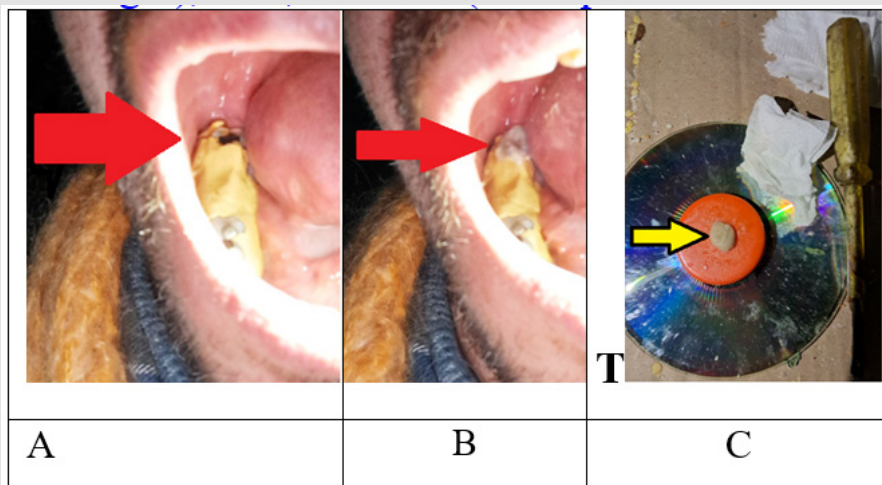
Figure 6: Site of secondary restoration and additional inlay after 20 days.

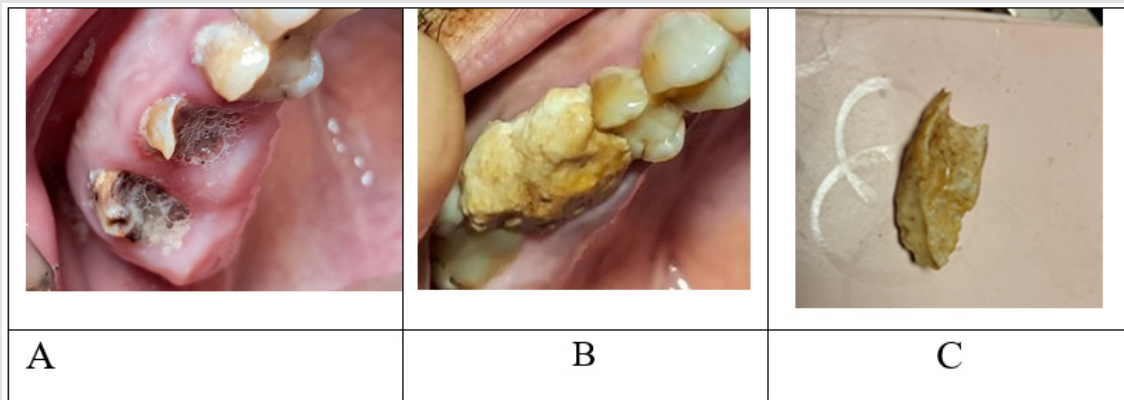
Figure 8: Fully destroyed teeth (6 and 7) before (A) and after self-restoration, and sample of used dental epoxy prosthesis after 1 month of *in-vivo* working.

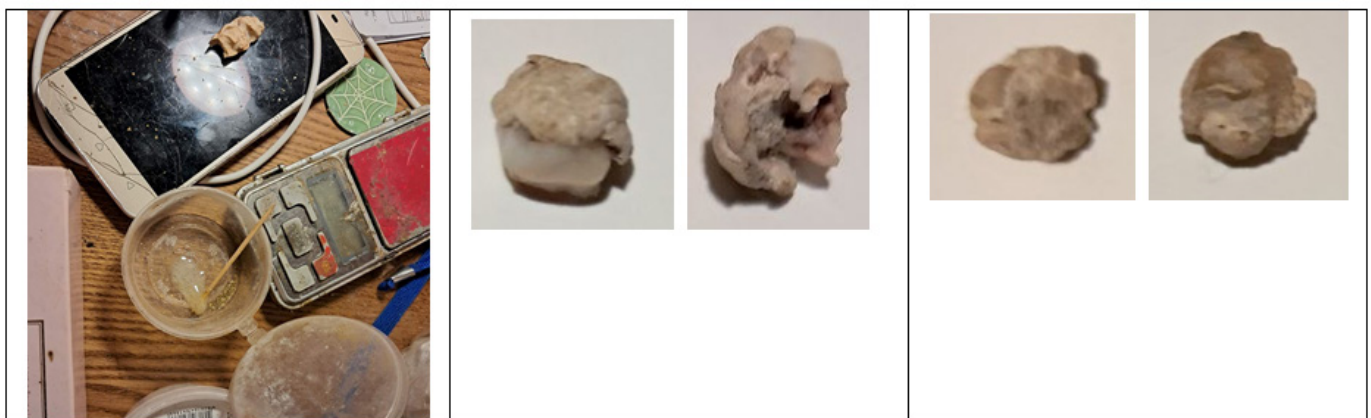
Figure 9:
 A. Example of mobile dental workstation
 B. And samples of epoxy-filling in molar
 C. Fallen epoxy-filling for molar and epoxy-filling for permanent adult tooth.

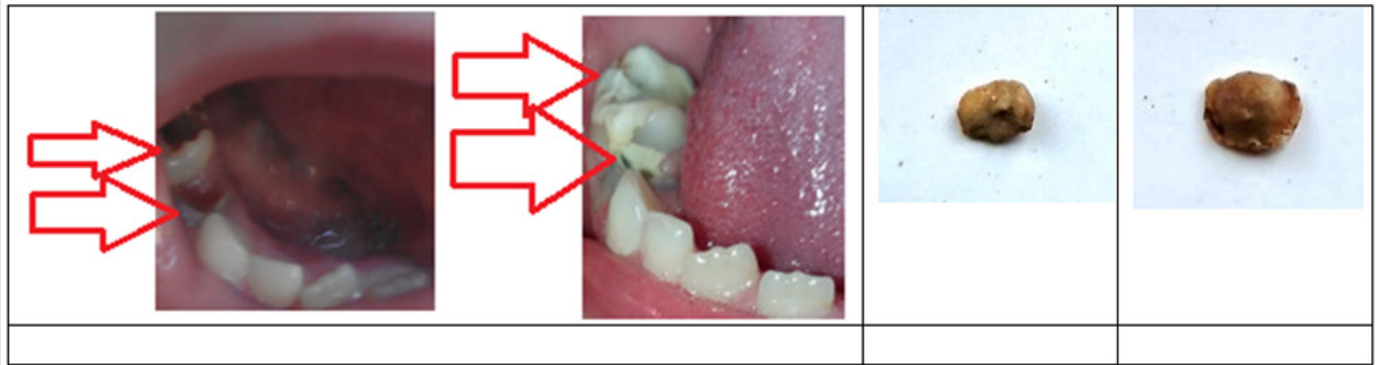
Figure 10: Example of restoration of destroyed children's molars in 2021, and fragments of epoxy-fillers after 4 years of work *in-vivo*.
